SHRINKAGE POROSITY

COLD SHUT/COLD LAP/MISRUN

CORE GAS POROSITY

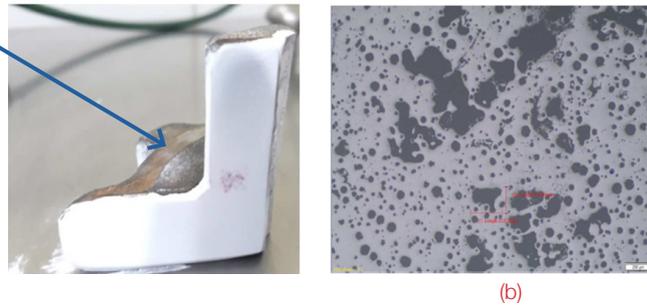
Shrinkage porosities are voids resulting from volume contraction during solidification and occur by inadequate feeding. Shrinkage porosity in cast iron is usually classified as macroshrinkage (primary shrinkage) and microshrinkage porosities (secondary porosities), their origin is the same, but they show differences in morphology and related to the solidification stage in which they were formed. Primary shrinkage occurs in the early stages of solidification with a low solid fraction in the different areas of the casting and is normally compensated by the feeders. On the other hand, secondary shrinkage occurs during the last stage of solidification, when most of the liquid flow is already interrupted and only graphite expansion can compensate for it. Related to the different stages of solidification during which they occur, primary shrinkage generally leads to large (Figure 1 a), smooth voids, while secondary shrinkage exhibits dendritic morphologies (Figure 1 b) (01).

▲ Figure 1(a): Macroshrinkage porosities in the feeders; (b) Microshrinkage porosities showing a dendritic morphology on their internal surfaces; (c) Porosity results prediction in a ductile iron casting

Fraction liquid and temperature results show the solidification path and when the portion of liquid is isolated. Hotspot and porosity (Figure 1 c) results show the location, volume and intensity of the shrinkage porosity.

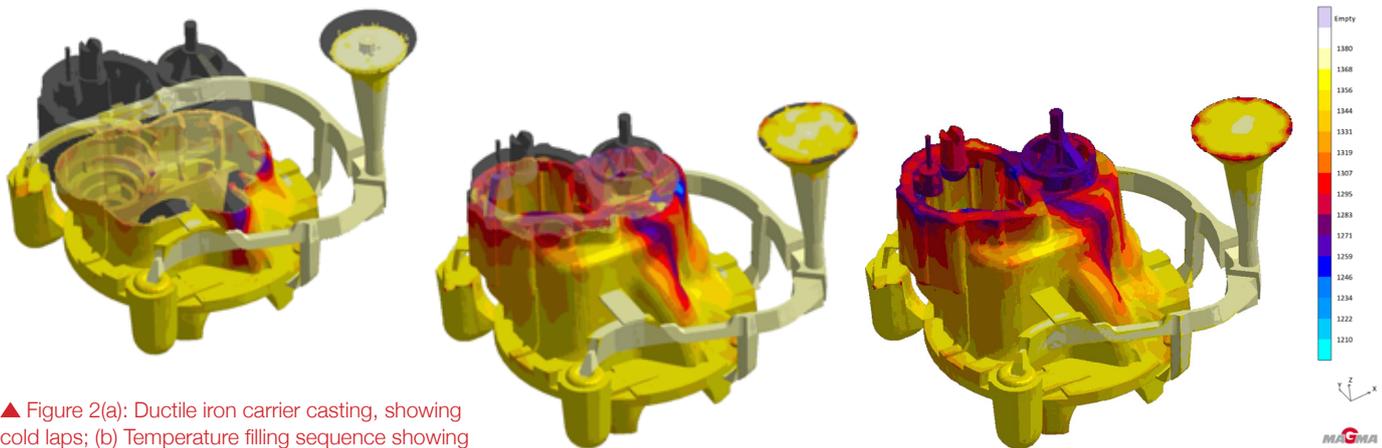
▲ Figure 2(a): Ductile iron carrier casting, showing cold laps; (b) Temperature filling sequence showing locations with lower temperatures and cold lap tendencies

A detailed analysis of the cavity filling temperature (Figure 2 (b)) and velocity behaviour allows to visualize the flow pattern and in which temperatures the flow streams meet. Filling temperature criteria results show at which temperature of the molten melt reaches a specific region of the mold. Low velocities and high air pressures in flow front or at the end of the filling can show similar defect characteristics even with relatively high temperatures.

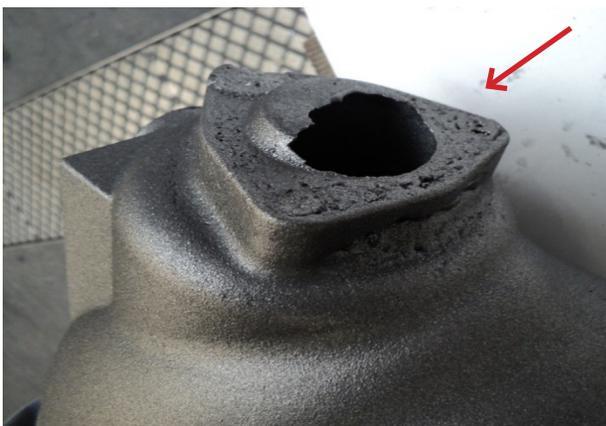
Core gas porosity is also called blowholes, where the cavities are characterised as relatively large bubbles with smooth surface. They are formed within the casting due to residual gas generated from the thermal degradation of the organic binders and, where applicable, of other volatile components. When using inorganic binder systems, gas formation primarily takes place due to the evaporation of residual moisture. The formed bubble is trapped in the casting and unable to escape during filling/solidification due to insufficient venting system. Usually this kind of defect is located adjacent to the core, just below or at the casting surface as shown in Figures 3 (a) and (b).

▲ Figure 3(a): Core gas porosity in the casting surface; (b) Current Core Gas Defect Risk on Cast result showing the location of the core gas porosities

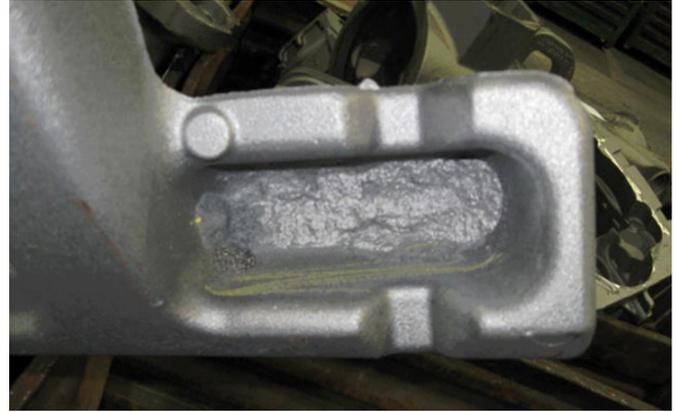
(a)

Burn on and penetration shows as a hard skin (Figure 4 a) adhered at the casting surface and are mainly caused by localized overheating of the sand mold or cores. Such over-heating can cause liquid metal to compromise the mold surface and entrain onto the surface of the mold (03).

▲ Figure 4(a): Hard skin adhered at the casting surface; (b) Original gating layout system; (c) Burn on simulation result showing the critical regions

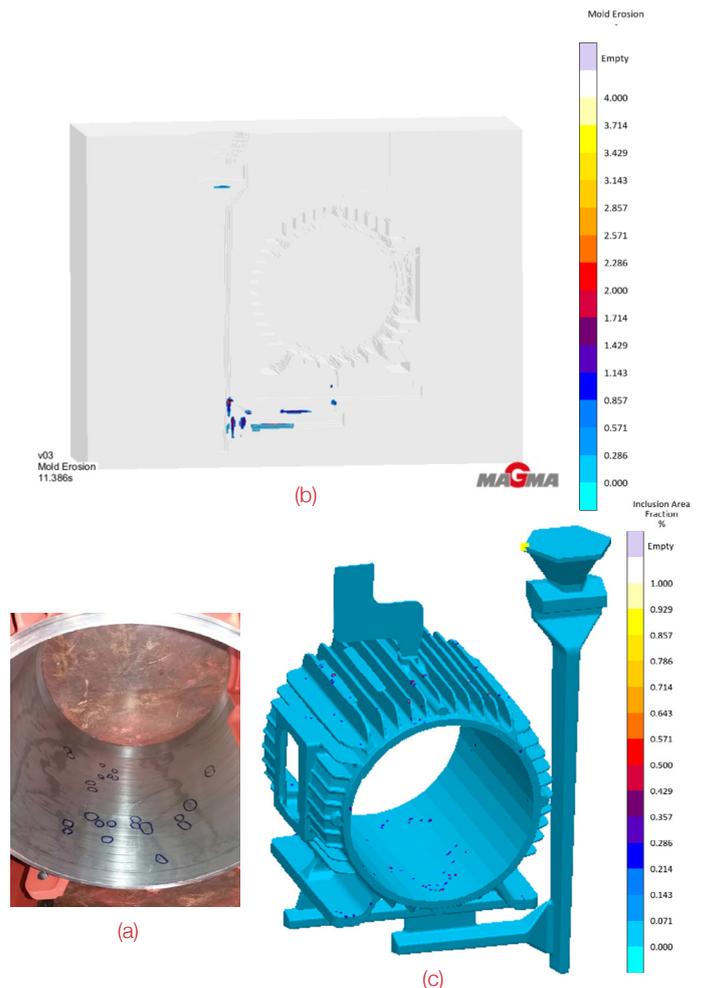
▲ Figure 6 (a): Sand inclusions and oxides in a electric engine housing surface; (b) Mold erosion results in a disamatic green sand mold; (c) Consequent sand inclusion area fraction in the critical location for machining (04).

Figures 6 a and b show respectively the filling criterion results of mold erosion and sand inclusion area fraction. Mold erosion result indicates where the sand was displaced and inclusion area fraction where the sand inclusions are going to be located in the surface of the casting.

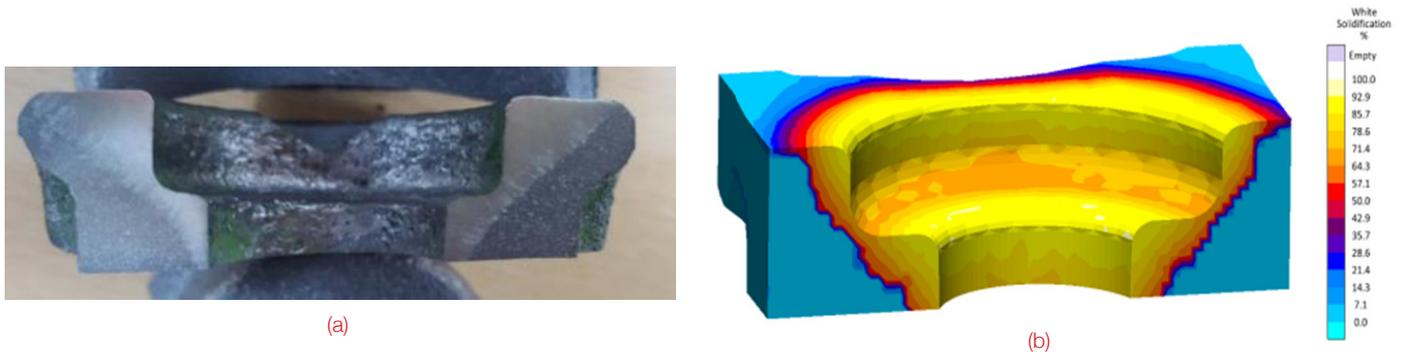
◀ Figure 7 (a): Part section showing the chilling region in white, caused by fast solidification rate due to chill application; (b) Simulation results of white solidification showing the carbides formation prediction in the same areas; (c) Original design of the part and the chill applied in blue (05)

Usually carbides are formed by difficulties in graphite nucleation and growth for solidification to proceed in the C-Si stable system before the metastable one is reached. It can be caused by fast cooling as shown in the figures 7 a,b and c or by segregation of elements such as Cr, Mo, Vn, that are carbides promoters and facilitate the solidification under the metastable system, in this last case the defect is called inverse chilling.

MAGMAiron is able to simulate the carbides formation in the casting taking into account the inoculation treatment, the cooling rate, and the chemical composition. The result fo white solidification shows directly the location and the percentage of the carbides in the microstructure as exemplified in the Figures 7 b and 8.

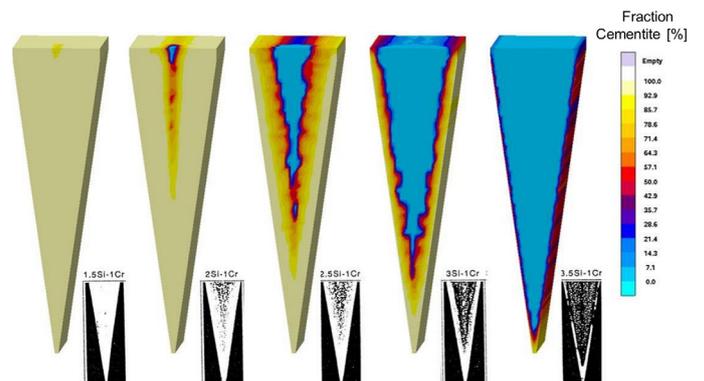
▲ Figure 8: Edge test simulation and real results, comparing the % of carbides with different Cr content in a cast iron composition

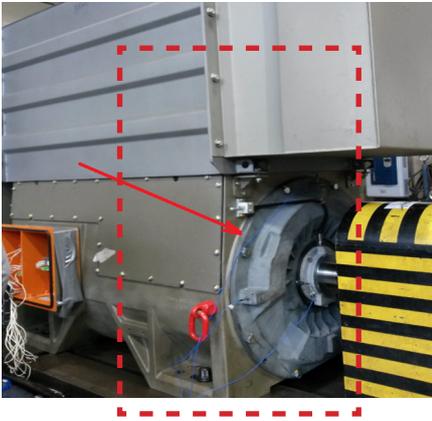
▲ Figure 9: Snapshot of the mounted engine cover (06)

During solidification and cooling of castings, stresses build up due to thermal gradients introduced by geometry complexity and constraints of core and molds. In some cases, the high stress level leads to permanent deformation that affects the dimensions of the final part. Figure 9 shows a grey iron electric engine cover which the flatness was measured and compared with simulation results. It is possible to observe that the high level of stresses in the inner thin area, around the ribs of the part (Figure 10 a) led to bending tendency, affecting the flatness of the component (Figure 10 b). Flatness deviation was measured in reality and in simulation, as shown in the graph of Figure 11.

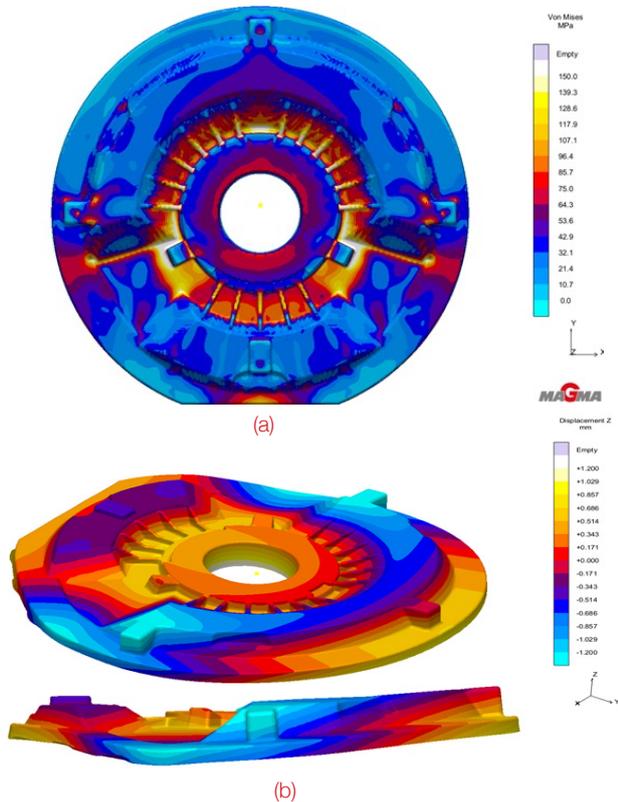
▲ Figure 10: (a) Von Mises stress level after the casting process, showing high stresses around the ribs; (b) Displacement results in Z direction showing the bending tendency (06)

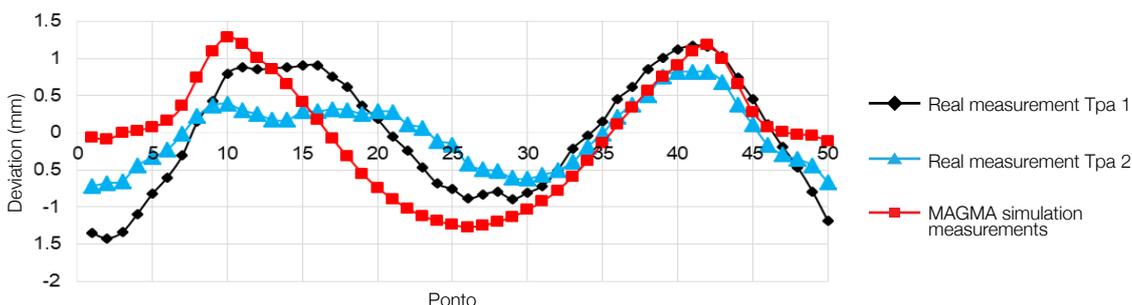
◀ Figure 11: Flatness measurements - blue and black curves show the real measurements of flatness deviation and the red curve shows the deviation in the simulation measurements, using the 6 points method (06)

Displacement results in X, Y, Z directions show the movement of the part from its original dimension; it's a combination of thermal shrinkage and shape distortion. With the resource of distortion factor it is easier to visualize the warpage. To evaluate the deviation of the final dimensions it's necessary to compare the distorted part with a reference geometry, or measure for example flatness or roundness using the measurement perspective with different methods such as, best fit, 3 points or 6 points. In Figure 11 the 6 points method was used and compared with real three dimensional machine measurement.

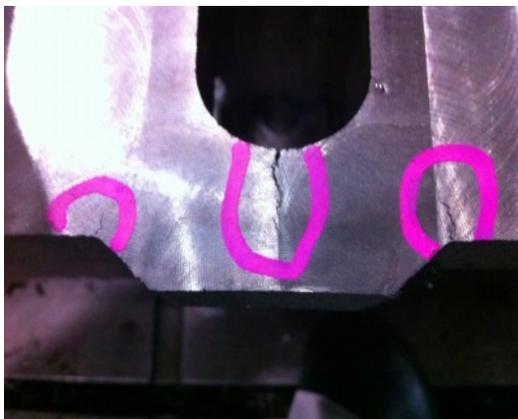
▲ Figure 12: (a) Cold cracks in the casting; (b) Cold crack criteria simulation result showing the critical regions for the defect

Cracks are discontinuities formed at relatively low temperature (below solidus temperature) as shown in the example of Figure 12 (a). The cold cracks occur when the stresses that build up in the part during the cooling phase exceed the ultimate tensile strength of material at a certain temperature. The crack may be transgranular or intergranular, depending on the relative strength of the grains and their boundaries and the temperature at which the crack is formed (07).
